Subject: Site Inspection, Molycorp, Small Fry Mine, M/037/022, San Juan County, Utah

Date of Inspection: August 19, 2003

M/037/022, Small Fry Mine, Molycorp

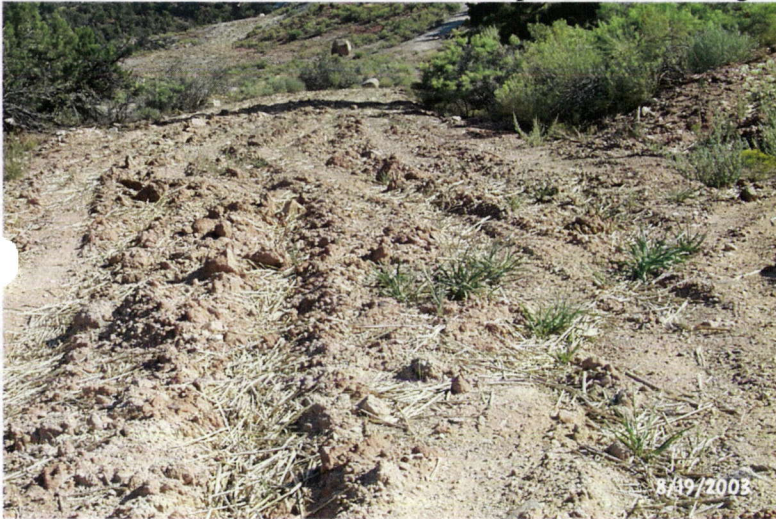
Vegetation is spotty with good growth in some places and very little in others (Photo 1). Most of the vegetation consists of grasses, and I am uncertain whether these are volunteer grain from the straw mulch or if it is seeded species.

Photo 1. Vegetation that has become established in parts of the reclaimed area.

It is still too early to say with certainty how successful revegetation efforts will be. The Division and operator should check the site again next spring.

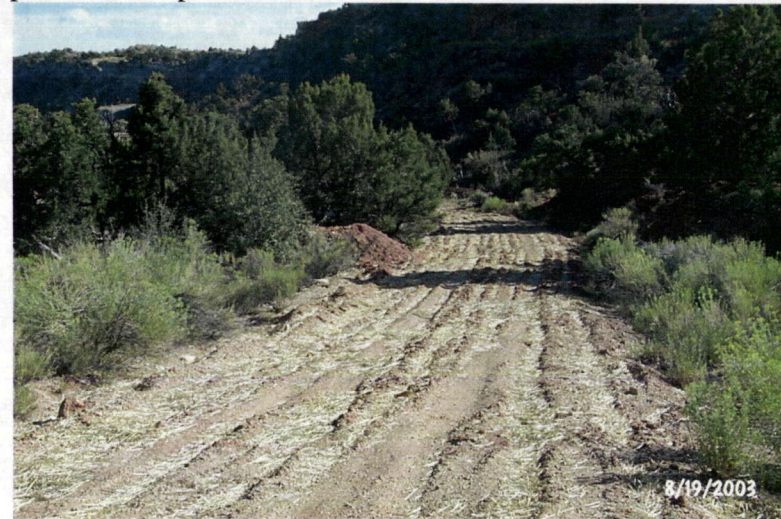
Some large rocks were placed at the beginning of the access road, and Denice Swanke of the BLM installed a sign asking people to stay out of the area. We saw no evidence of anyone trying to drive around the rocks to get into the area, but it does appear someone, perhaps the seeding contractor, drove over some of the roads after they were ripped (Photos 2 and 3).

Photo 3. Another view of one of the roads.

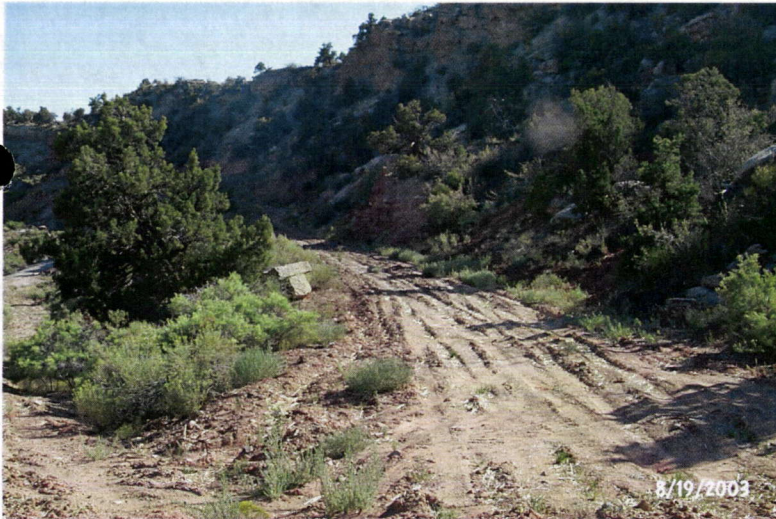
Photo 2. Two roads near the mine site. Note how it appears someone drove over the area after it was ripped.
